Impact of 5 m Setback – October 2019

Waimanu Farm Case Study

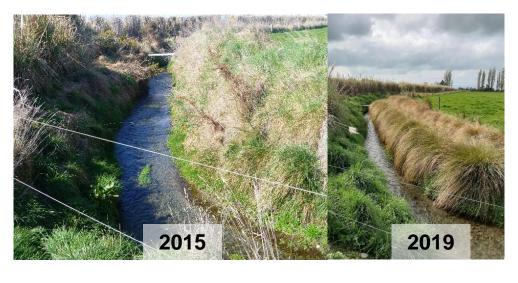
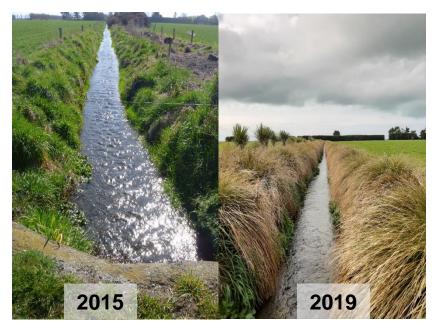
Figure 2: Waimanu Farm Stream Restoration Before and After Rebattering and Planting

- Stabilised and rebattered the banks of the waterways (Figure 2)
- Planted over 3000 plants
- Extended fencing to create setbacks of between 2-3 m
- Installed 3 bioreactors to treat run-off from the tile drainage system

Extensive monitoring of the water quality in these drains have shown a significant reduction in temperature and aquatic weeds, however only limited improvements in water chemistry or macroinvertebrates². The reduction in weeds has meant no mechanical clearance of the stream is required anymore, which should result in an improvement in macroinvertebrate communities over time by reducing the amount of disturbance in the stream bed. A lack of change in the water chemistry is likely due to overland run-off being low risk activity on this property in most places.
